UPPER HUDSON RIVER WATERSHED
JACKSON CREEK BASIN

JACKSON SUMMIT RESERVOIR DAM
FULTON COUNTY, NEW YORK

NY 153
PHASE I INSPECTION REPORT
NATIONAL DAM SAFETY PROGRAM

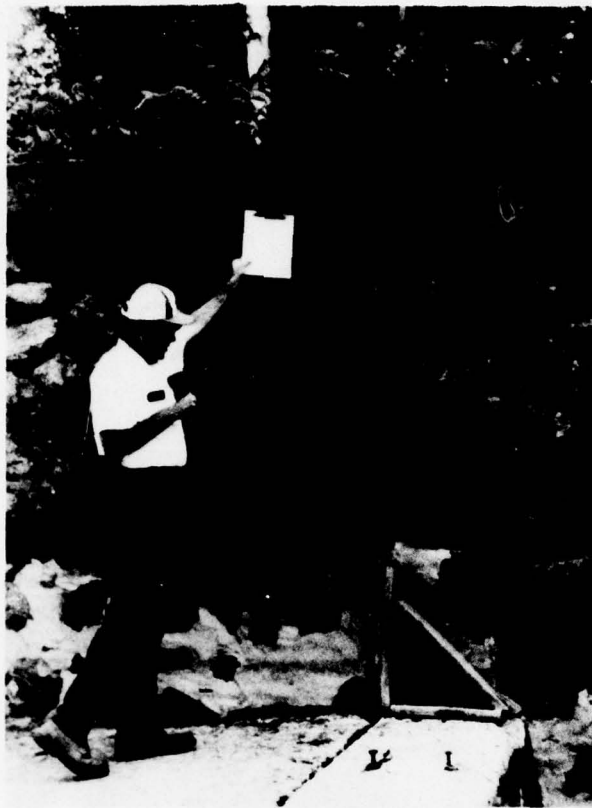
FIGURE 3 LEFT WINGWALL OF SPILLWAY

i) The left stone masonry wing wall of the spillway is in generally good condition with some recent patching. One structural crack was noted (Fig. 3, Appendix D) at upstream end of spillway overflow section.

iii) The approach slab was in good condition. The junction between the approach slab and the spillway sill (Fig. 3, Appendix D) was open about 1 inch, and other slab joints were noted to be only slightly open.

1. Joints in the spillway approach and discharge slabs should be sealed, with vegetation removed.
2. The junctions between the spillway sill and the adjacent concrete slabs, and the deteriorated areas of all other concrete and/or masonry appurtenances should be repaired.
3. The gate house basement and its access way to the pipe inlet control valves should be lighted, the ladder repaired, and railings added.
4. Low woody growth on the dam should be removed. Shallow rooted trees on the embankment should be cut down; deep rooted trees should remain.
5. A specific program for periodic inspection and maintenance of the dam embankment and its appurtenant structures should be established and followed.

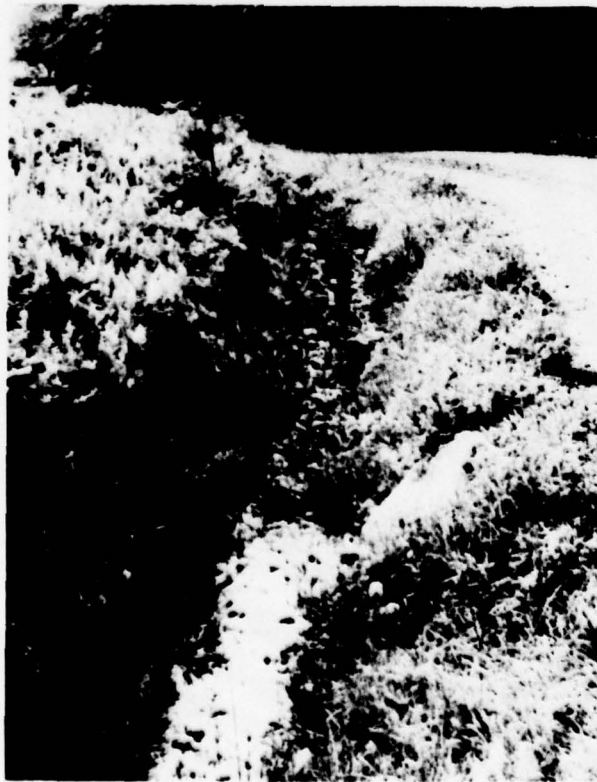
FIGURE 4 SEEPAGE CHANNEL DOWNSTREAM OF TOE

Inspection of the downstream face of the embankment revealed no evidence of seepage. However, approximately 50 feet downstream of the embankment toe, a seepage channel was noted (Fig. 4, Appendix D) which carried a clear steady flow of water into Jackson Creek. It was observed that the ground was swampy from approximately 50 feet downstream of the embankment toe to beyond the dirt road starting about 100 feet left of the gate house and continuing along almost the entire length of the dam (Fig. 5, Appendix D). All seepage observed occurred in virgin soil. A boil was noted at the outlet of the 16-inch diameter corrugated galvanized iron pipe culvert which allows the seepage runoff to pass under the Jackson Summit Road (Fig. 6, Appendix D). The soil was agitated creating a cloudy suspension of material. After

Due to the seepage beyond the toe of the embankment, it is recommended that borings be drilled through the downstream slope of the embankment, penetrating into the virgin soil, to establish the properties of both the embankment and the foundation materials. Later, piezometers may be installed in these borings to establish the seepage characteristics through the embankment. Subsequent stability analysis will provide a better understanding of the safety of this dam. If it were found safe, necessary protective measures to prevent piping failures (e.g. a subdrainage system and/or injection grouting) would then be recommended. Test pits should be dug along the centerline of the dam crest to verify the existence of the cutoff wall; the vertical dimension of the wall should be checked by coring.

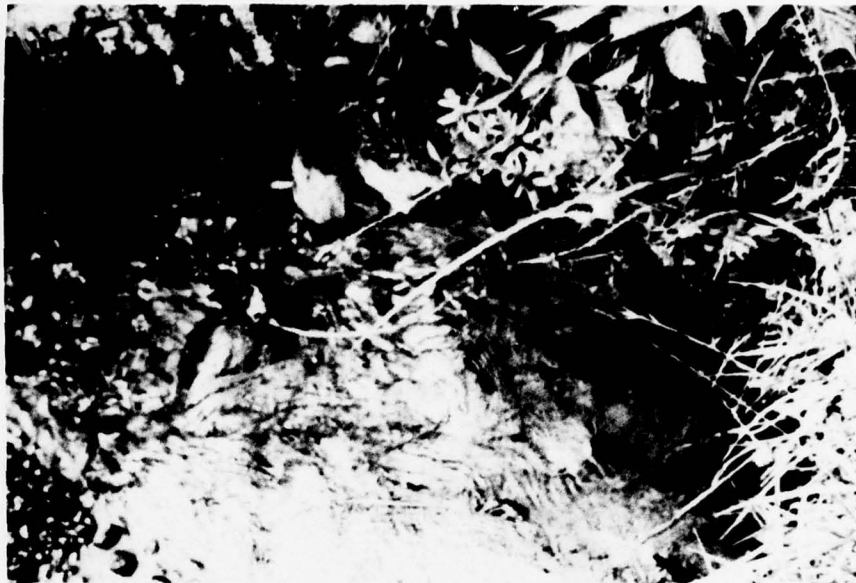
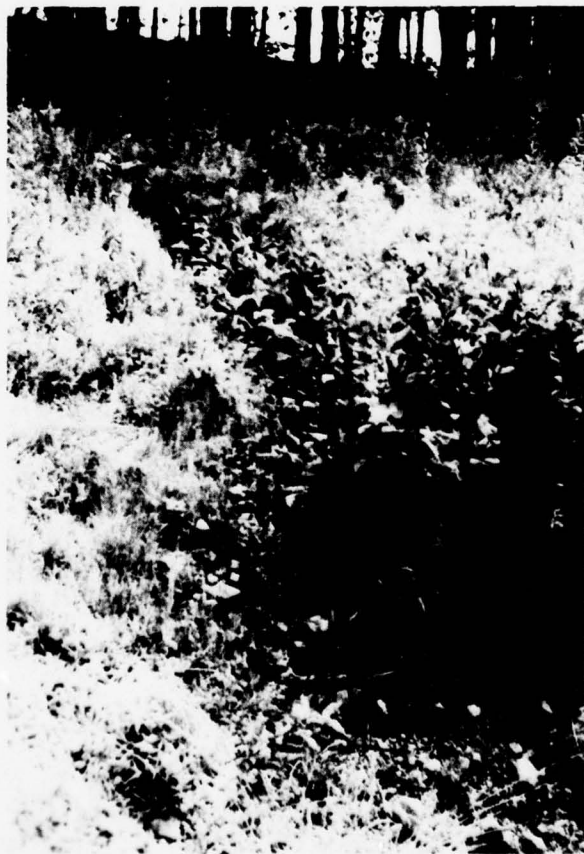
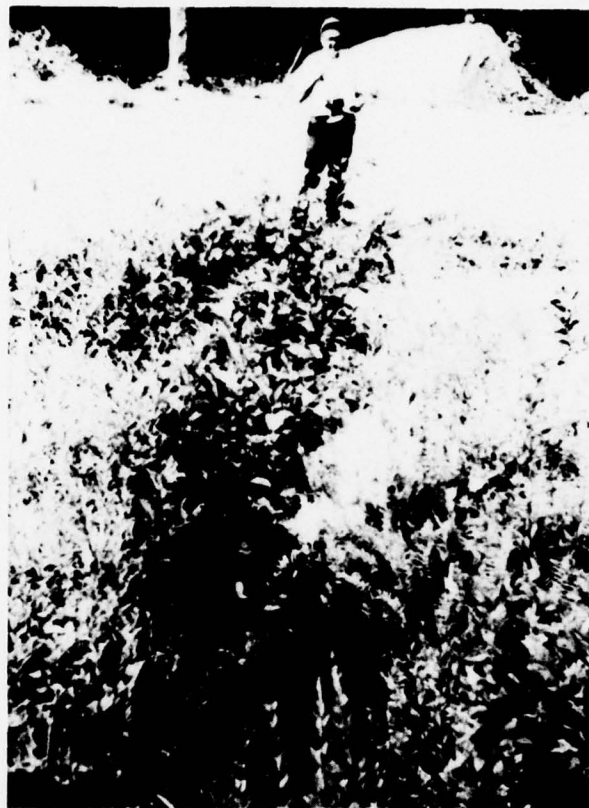
about 5 minutes the water was observed to still be cloudy, but after approximately 1½ hours the water was once again clear. Seepage emergence (clear) was observed at many points downstream of the toe (Figs. 7-10, Appendix D). We were informed that this seepage had been occurring for about 20 years.

FIGURE 7 SEEPAGE EMERGENCE

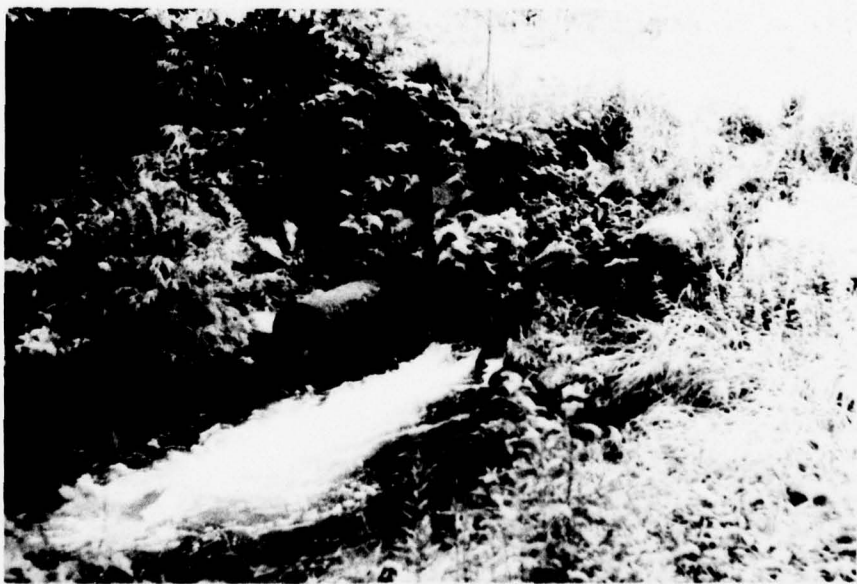
FIGURE 12 DISCHARGE OF 20-INCH DIAMETER OUTFLOW PIPE

On the day of inspection there was discharge from the 20-inch diameter outflow pipe into Jackson Creek (Fig. 12, Appendix D), on the far side of Jackson Summit Road. The valves for the 8-inch diameter intake pipe, the 20-inch diameter intake pipe, and the 20-inch diameter "mud" pipe were each in turn opened and closed, and the flow observed. All the valves appeared to function properly and are easily accessible via turning wheels mounted on valve standards on the floor of the gate house which are connected to the valves by 30-foot valve stems. The flow from the "mud" pipe was cloudy.

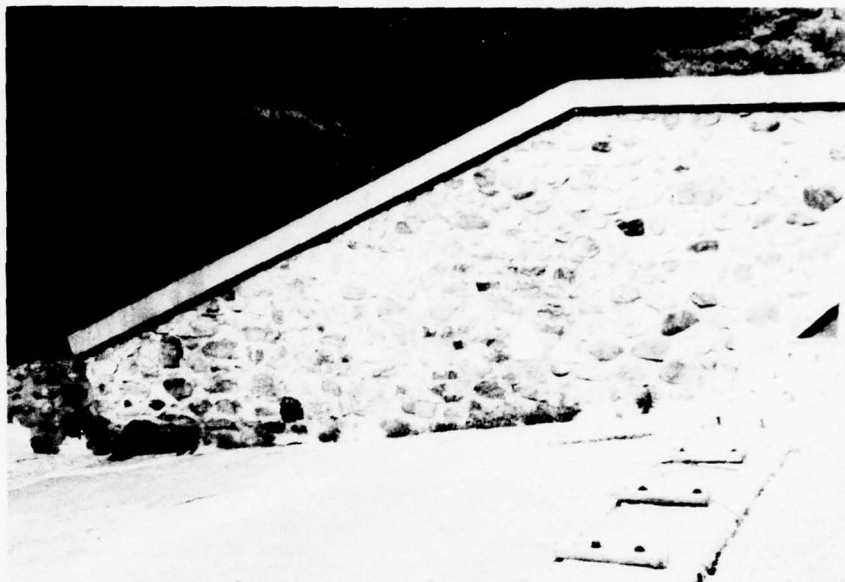
FIGURE 13 RIGHT WINGWALL OF SPILLWAY

ii) The right stone masonry wing wall (Fig. 13, Appendix D) is in generally good condition with some minor spalling of recent patch concrete. Some minor cracks were noted, one in the top sill at the upstream end of the spillway sill and another crack a short distance away downstream.

iv) The spillway sill has undergone considerable spalling and erosion along the downstream face (Fig. 14, Appendix D). Flashboard mounts at the crest are badly deteriorated (Figs. 13 and 14, Appendix D). At the time of inspection, flashboards were not in place.

v) The discharge slab was in good condition with a half inch gap between it and the spillway sill. Minor vegetation was growing in cracks at the base of the wing walls (Fig. 13, Appendix D).
